Bioventing at
Operable Units 5, 8, 9, 10, and 11

Loring Air Force Base
SEMIANNUAL PERFORMANCE REPORT
August — December 1997

March 1998
Revision B

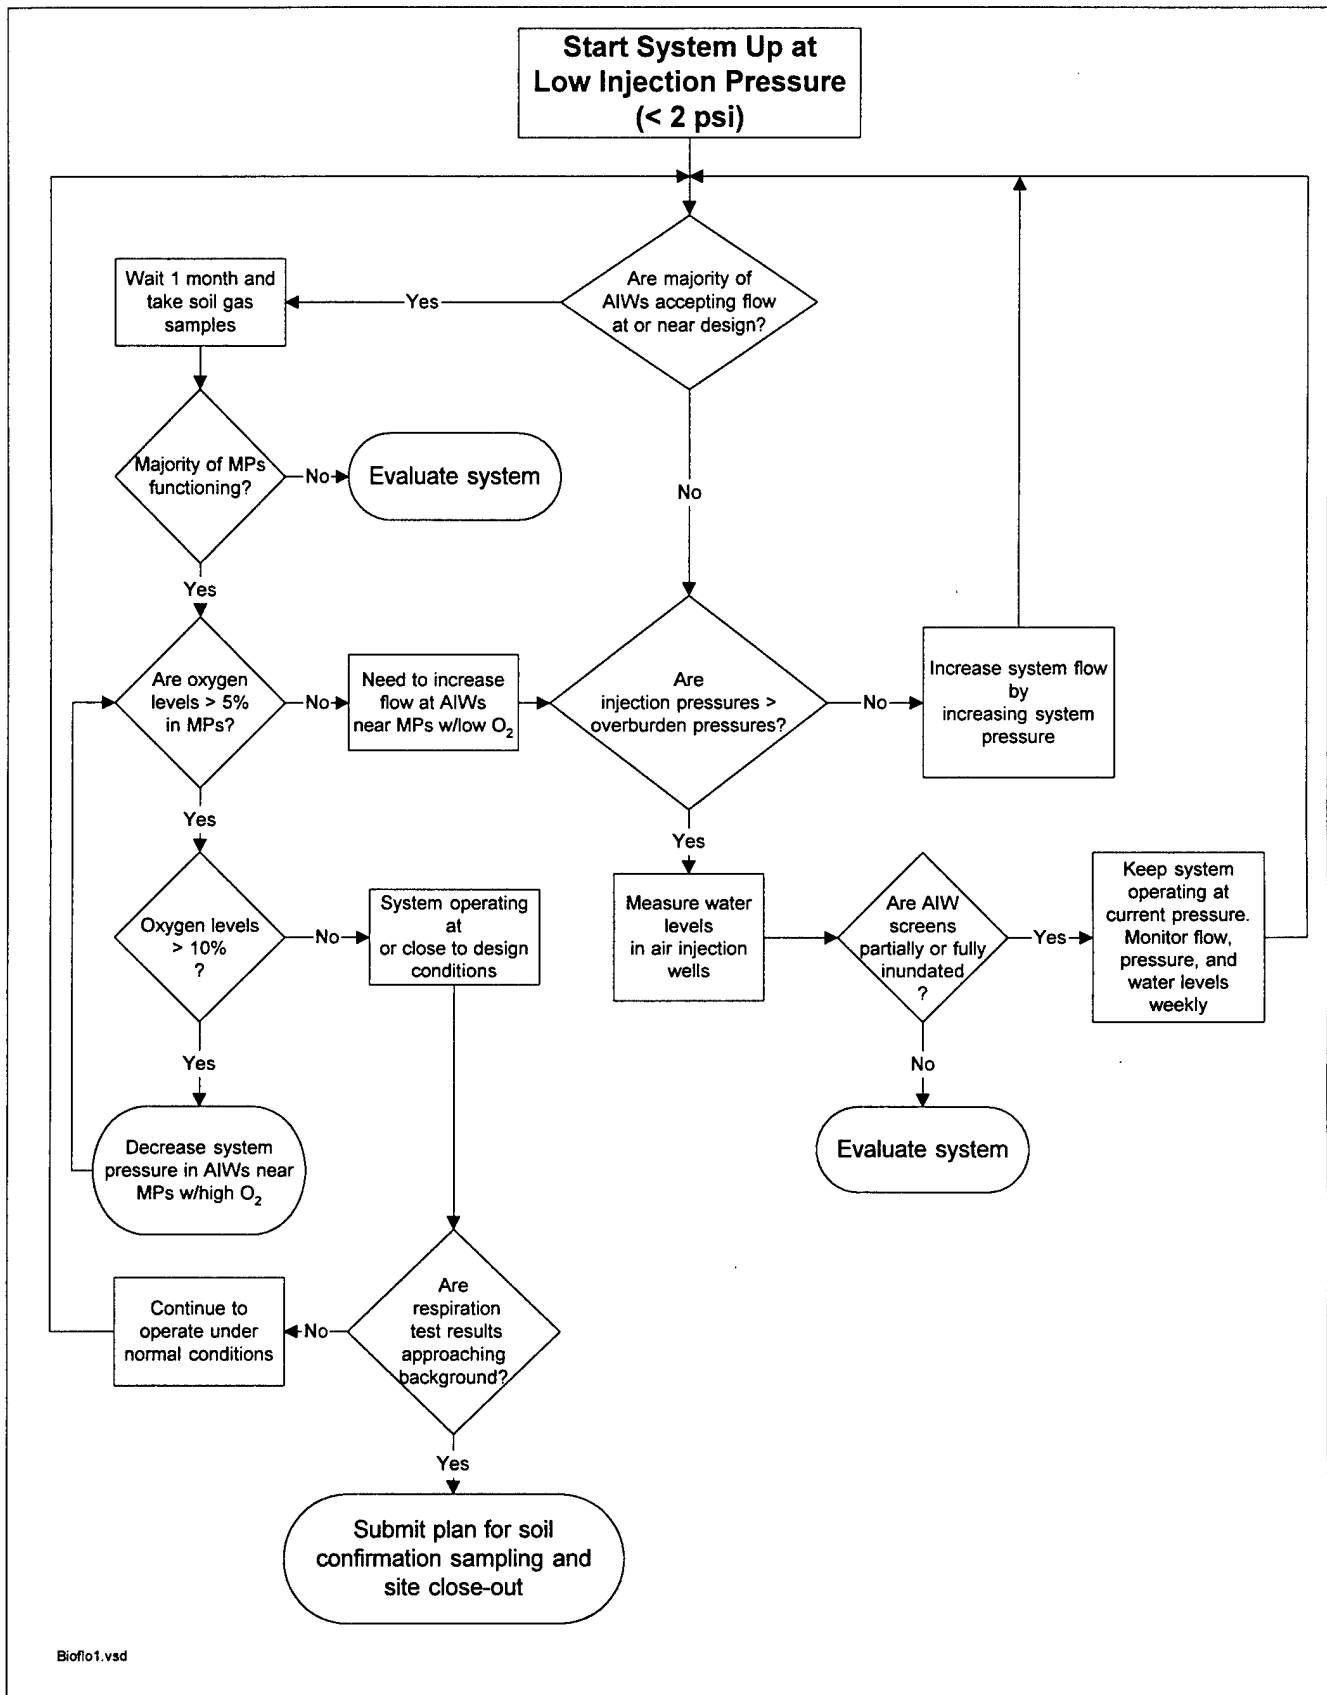
Figure 1-1 Bioventing Process Operation Decision Chart

The objective of this report is to present operations data and an evaluation of bioventing system performance, including site status, problems identified, and recommendations. Operations guidance, summarized in Figure 1-1, facilitates identification of required system changes during normal operations and when remediation is nearing completion.

Soil gases are sampled to quantify subsurface aeration rates. AFCEE protocol recommends maintaining an oxygen level of at least 5 percent, the level required to maintain oxygen-limited aerobic degradation (AFCEE 1992); this level is used as a reference point for operation of the biovent systems. Oxygen levels are measured either by taking soil gas samples from the MPs or by in situ oxygen meters. If oxygen levels are found to be below 5 percent at any MP, flow rates from adjacent AIWs are increased to raise oxygen concentrations at that location (see Figure 1-1).

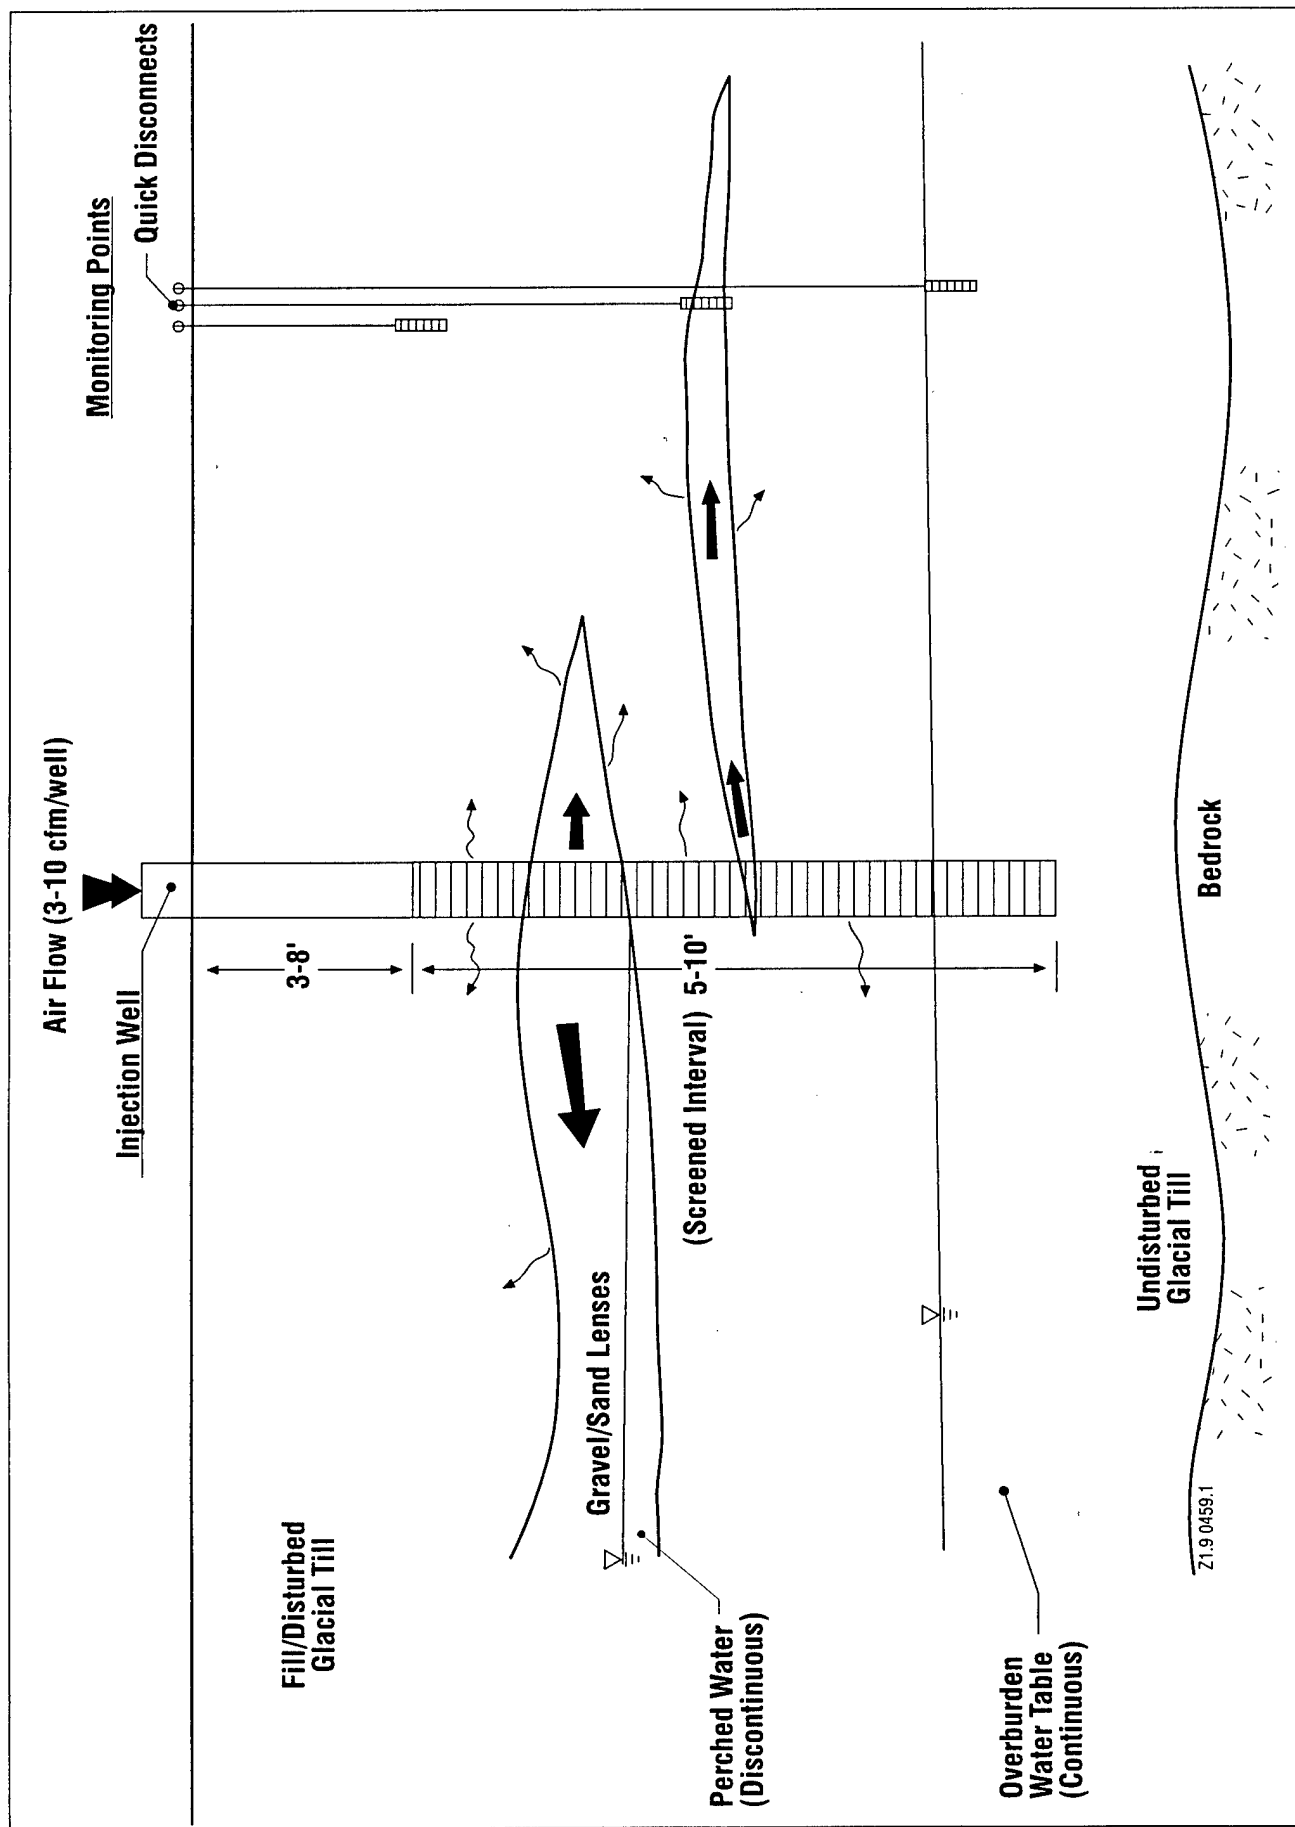
Figure 1-2 Bioventing Conceptual Model

Experience gained at Loring AFB enhances understanding of how the biovent systems operate in relationship to site-specific hydrogeology. Figure 1-2 is a conceptual model of a typical bioventing site. In general, each site consists of glacial till (either natural and/or worked), and lenses of higher-permeability material (e.g., gravel, sand) containing perched water. The overburden groundwater table is usually below the area being treated by bioventing, so most groundwater influences on air injection are likely caused by perched groundwater (historic water table depths determined the depths of the screens). Perched water also affects the collection of soil gas samples in MPs.

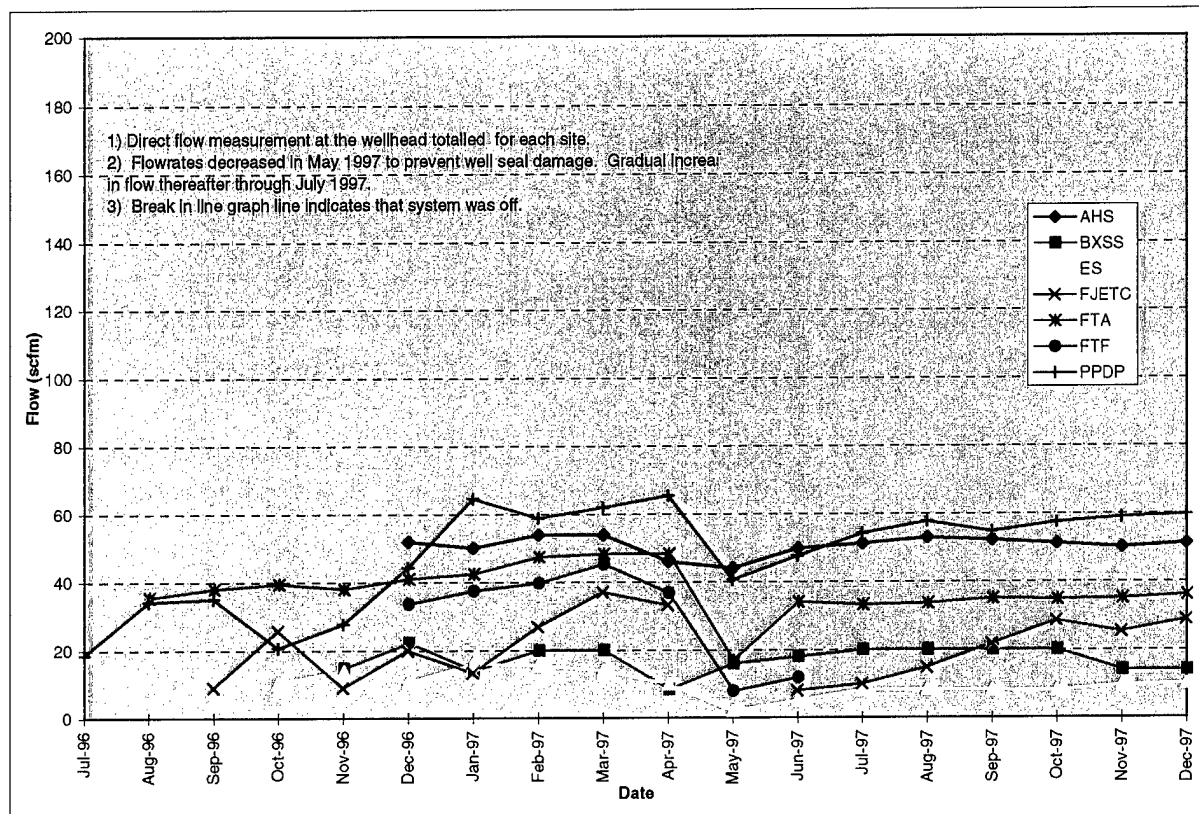
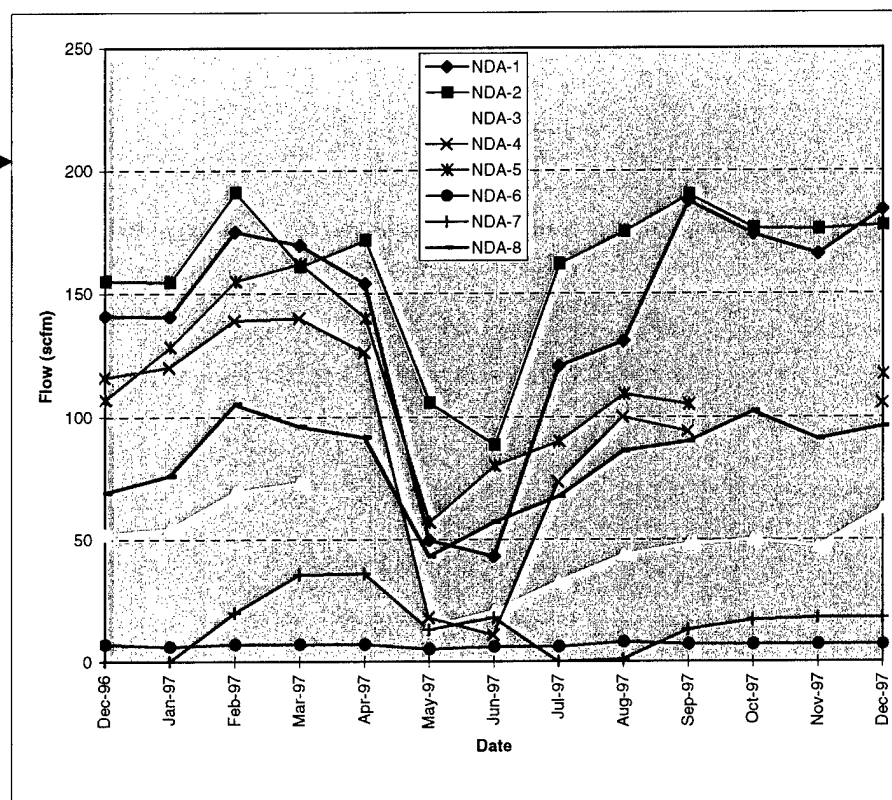
← NDA System not yet installed from Jul - Nov 1996. →

Figure 3-1
 Monthly Air Flow

Figure 3-1 plots total monthly air flow at each site since startup. In general, there was a midyear downturn in monthly total flow at each system in 1997, related primarily to the wet weather that spring. Numerous NDA AIWs not performing, as noted in the last semiannual report, were again noted during the second half of 1997. NDAs 1, 3, 4, 7, and 8 continued to have nonfunctional AIWs, but several AIWs in these areas started functioning as designed. Further discussion of this is included in site specific sections presented later in this report.

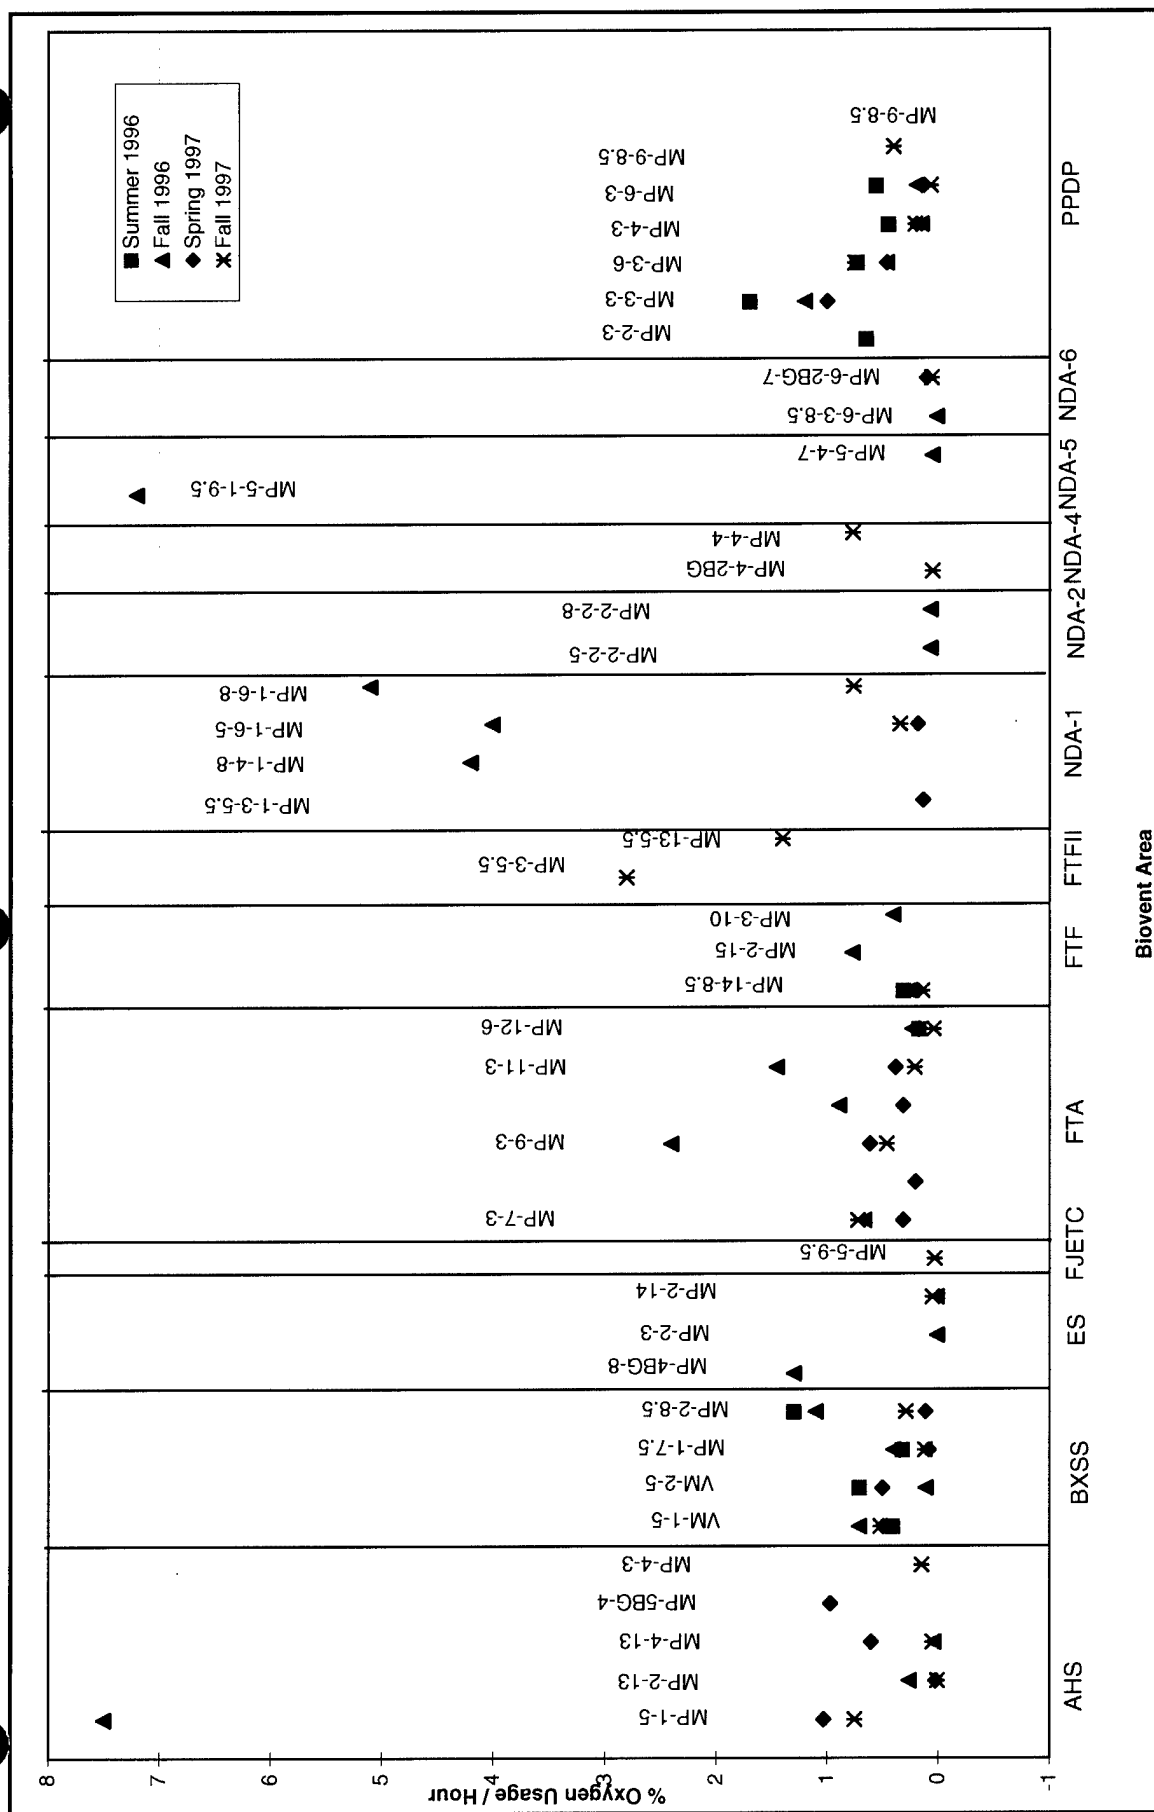
Figure 3-2
Respiration Test Results by Biovent Area

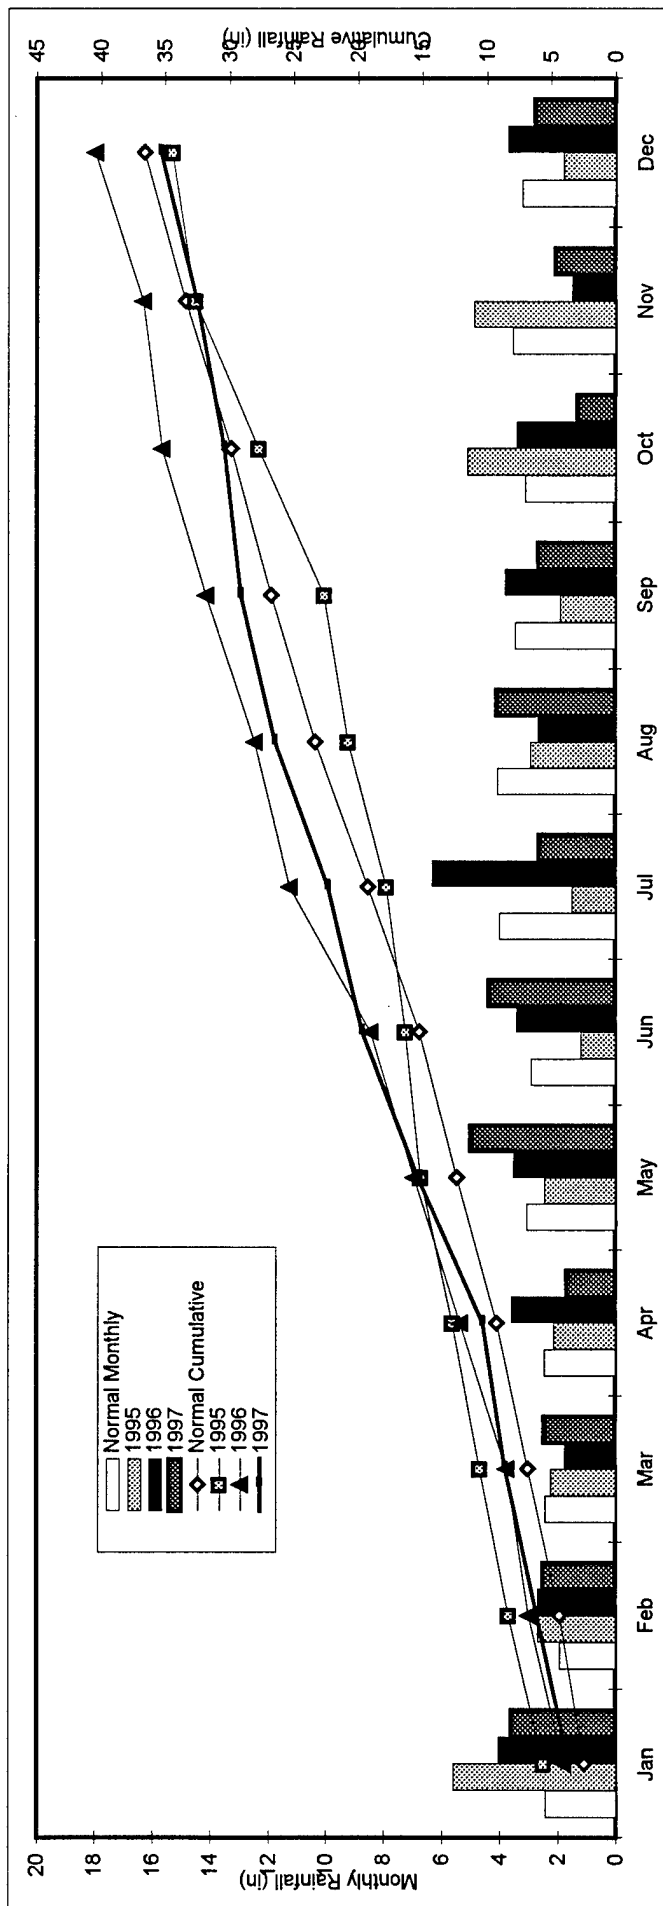
Figure 3-3 Daily and Cumulative Rainfall Amounts

Table 3-3 tabulates rainfall data recorded at the weather station in Caribou, Maine, over the past year, and Figure 3-3 illustrates daily totals and cumulative values for the past 3 years. The graph clearly shows that precipitation during April through September 1996 and 1997 have exceeded normal levels. Combined with snowmelt, these high levels may have had an impact on several of the biovent systems as noted in the last semiannual report. Saturated soils have caused air injection rates to be lower than design flow, and several MPs were affected by saturation levels, resulting in reduction of monitoring data. Rainfall amounts from October through December were close to normal. Most inundated wells noted in June and July were either only partially inundated or were not inundated from August through December, primarily due to the decrease in infiltration. Although several wells dried up, partially saturated soils did not allow air flow in several AIWs.

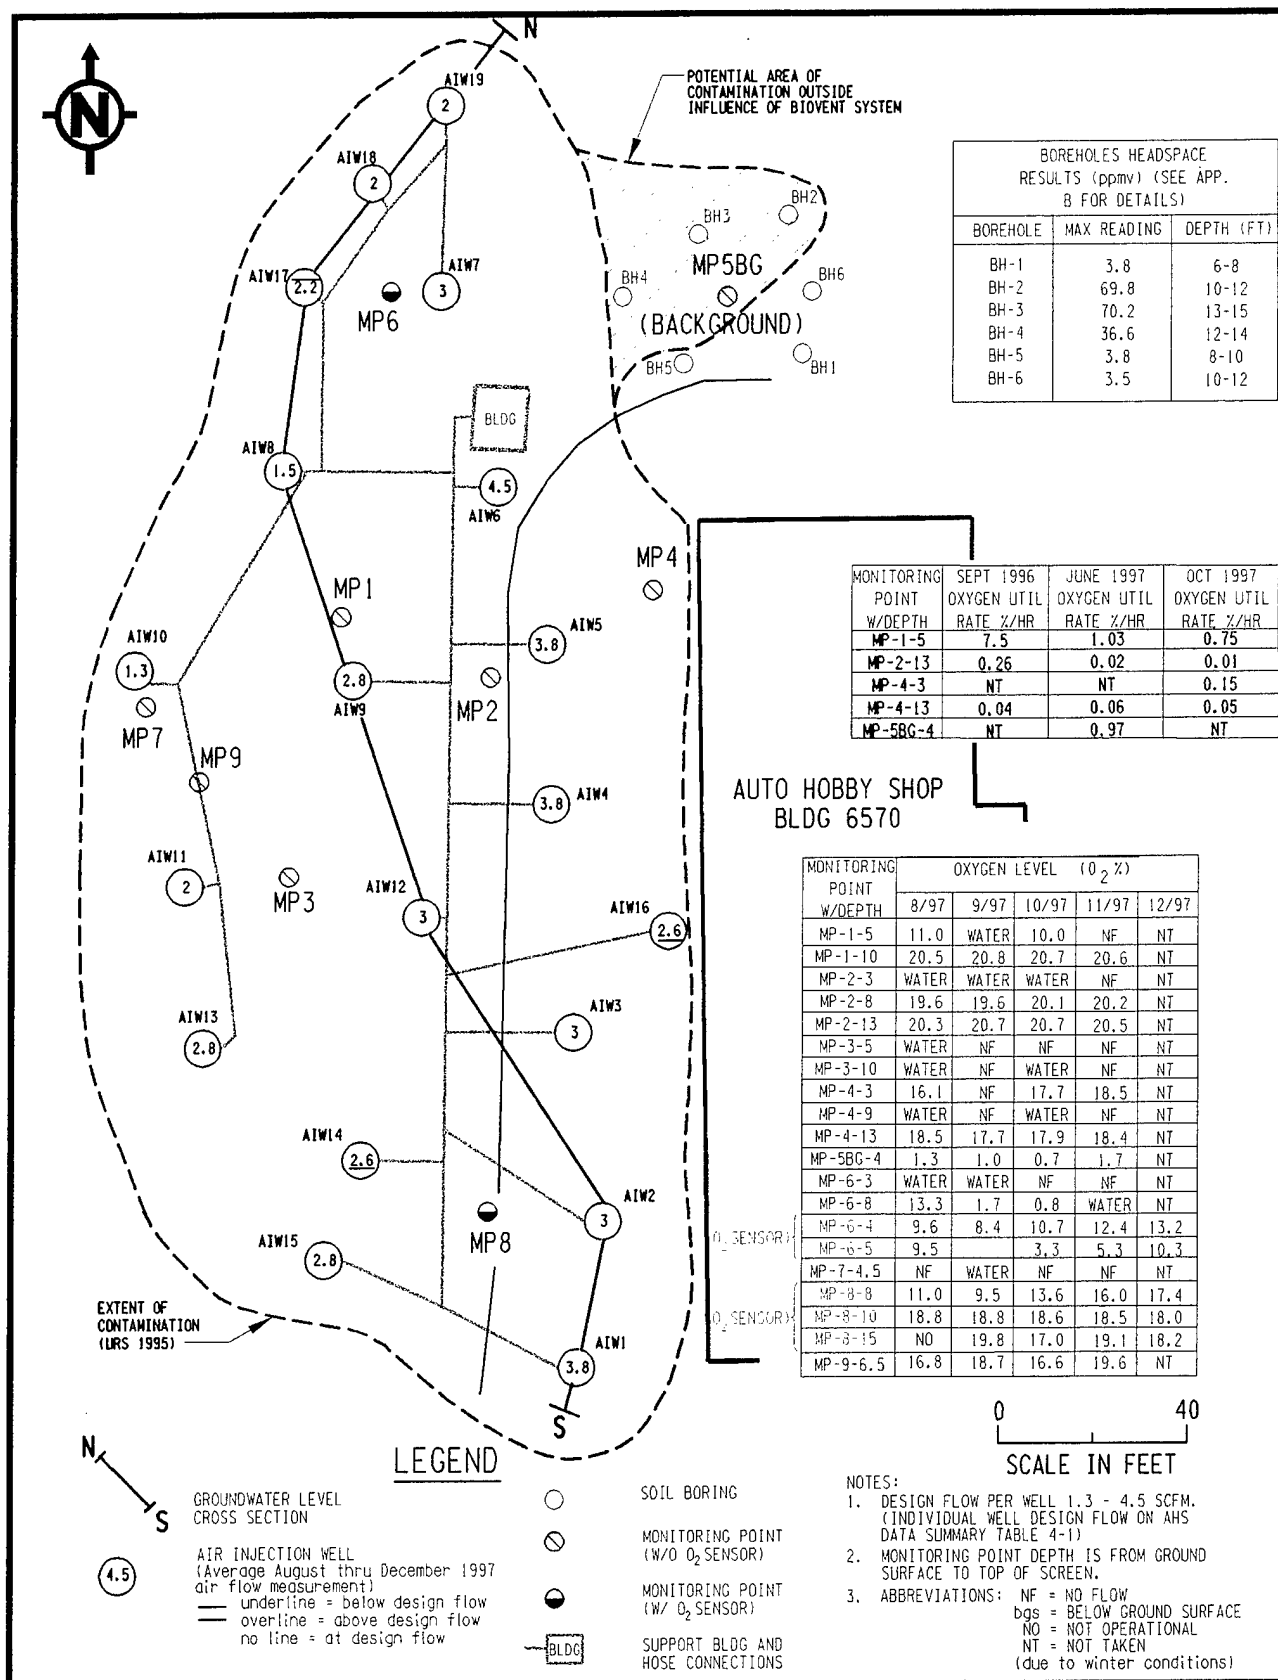
Figure 4-1
AHS Biovent System Layout
and Average Wellhead Flow

Overall Recommendation for AHS: Most of the site is operating per design, and most MPs are providing data. No significant operational changes to the air flow settings or improvements to MPs are recommended for the AHS site at this time. Oxygen levels are below 6 percent at MP-5 and MP-6, and the oxygen utilization rate at MP-1 is 0.75 percent/hour. Therefore, the system should remain in operation until all areas of the site reflect background conditions. The distance to the potentially contaminated soils near MP-5BG is beyond the radius of influence of the nearest AIWs; therefore, a new AIW is recommended to be added near boreholes 2, 3, and 4 (Figure 4-1).

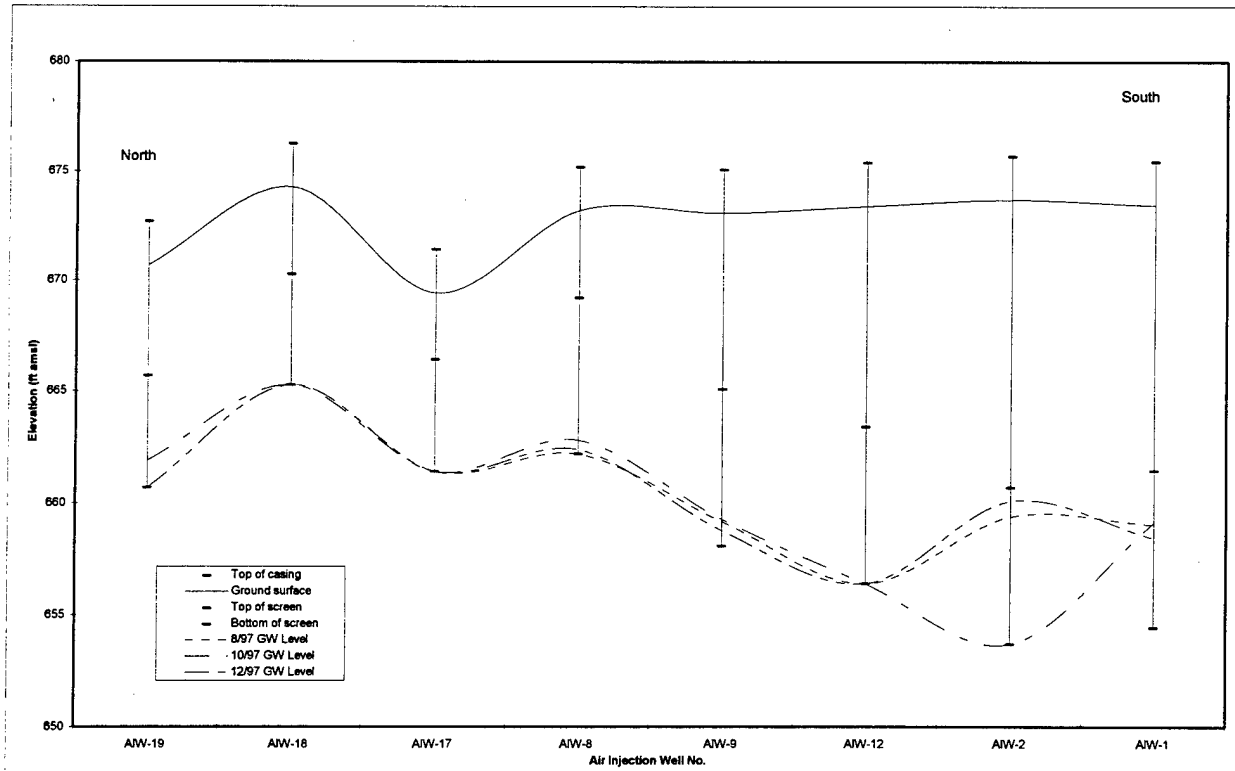
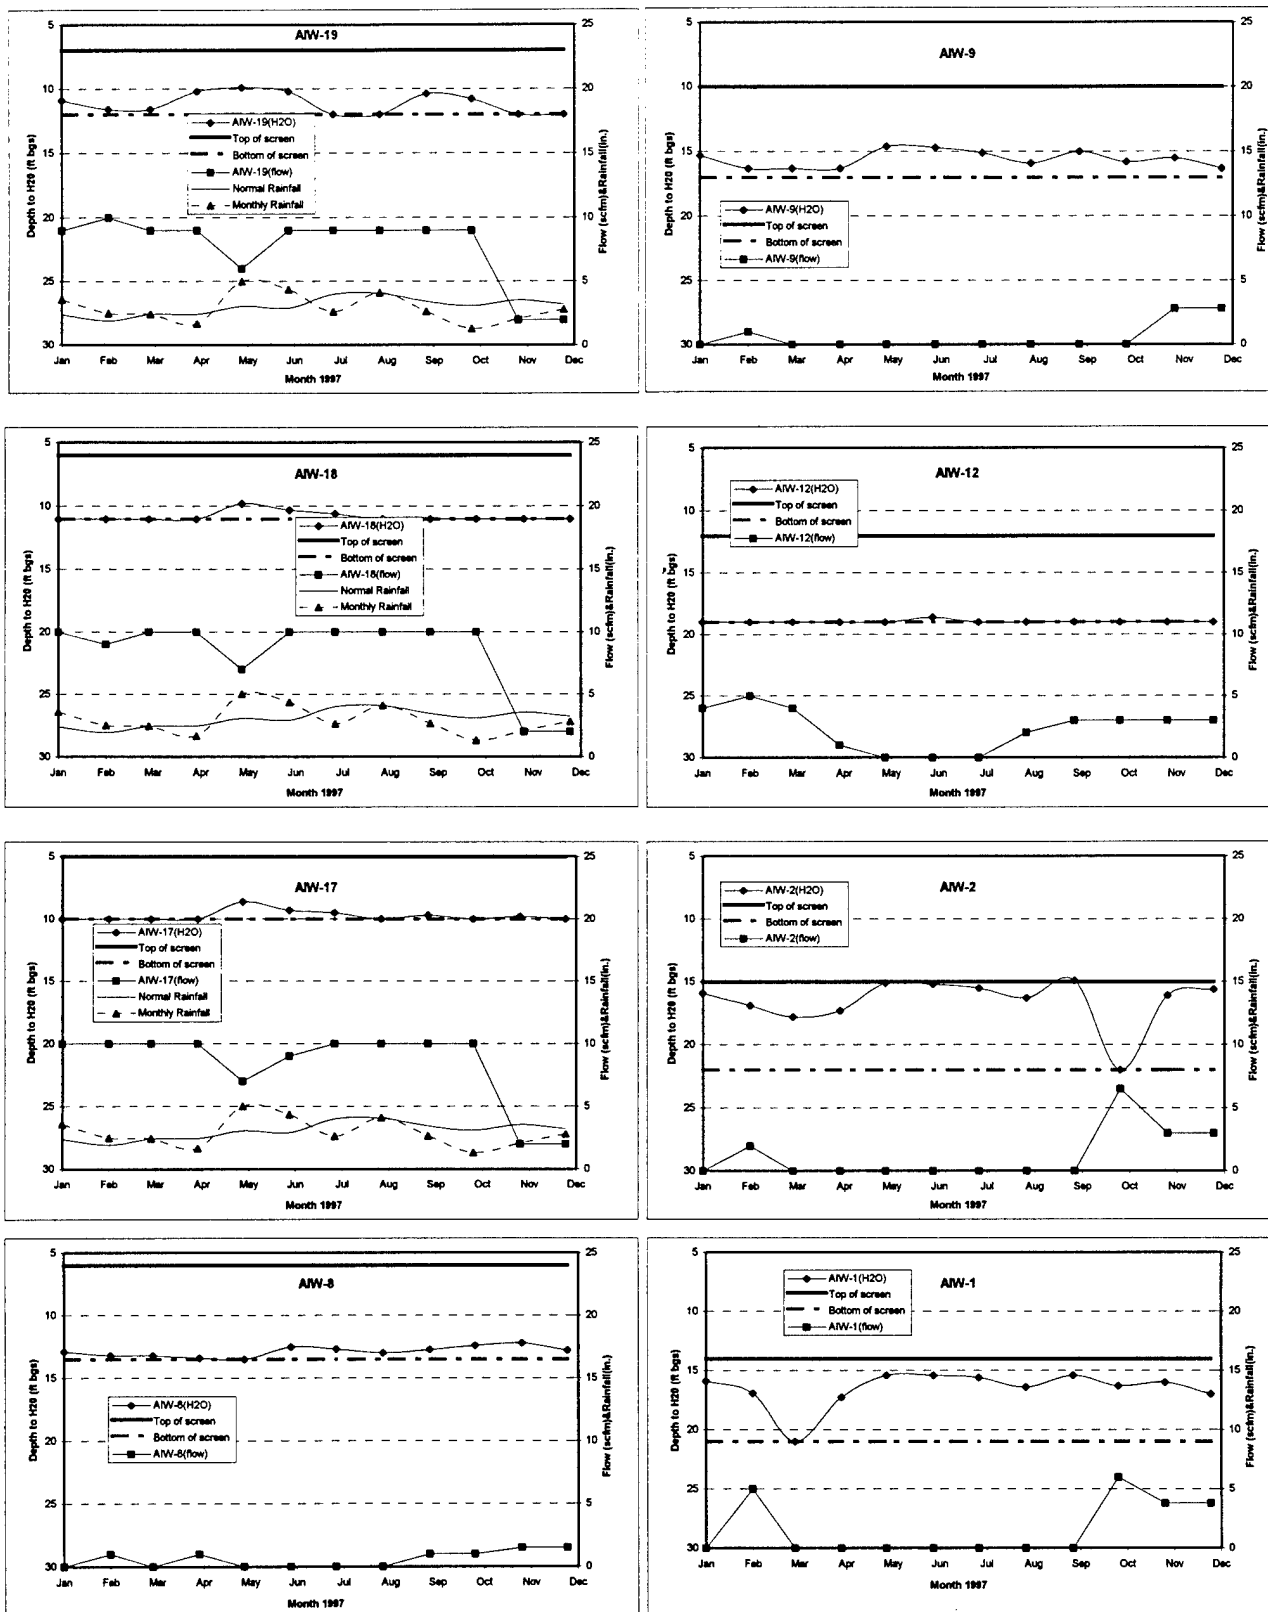
North / South Cross Section at Auto Hobby Shop

Figure 4-2 AHS Groundwater/Air Flow Relations Along North/South Section

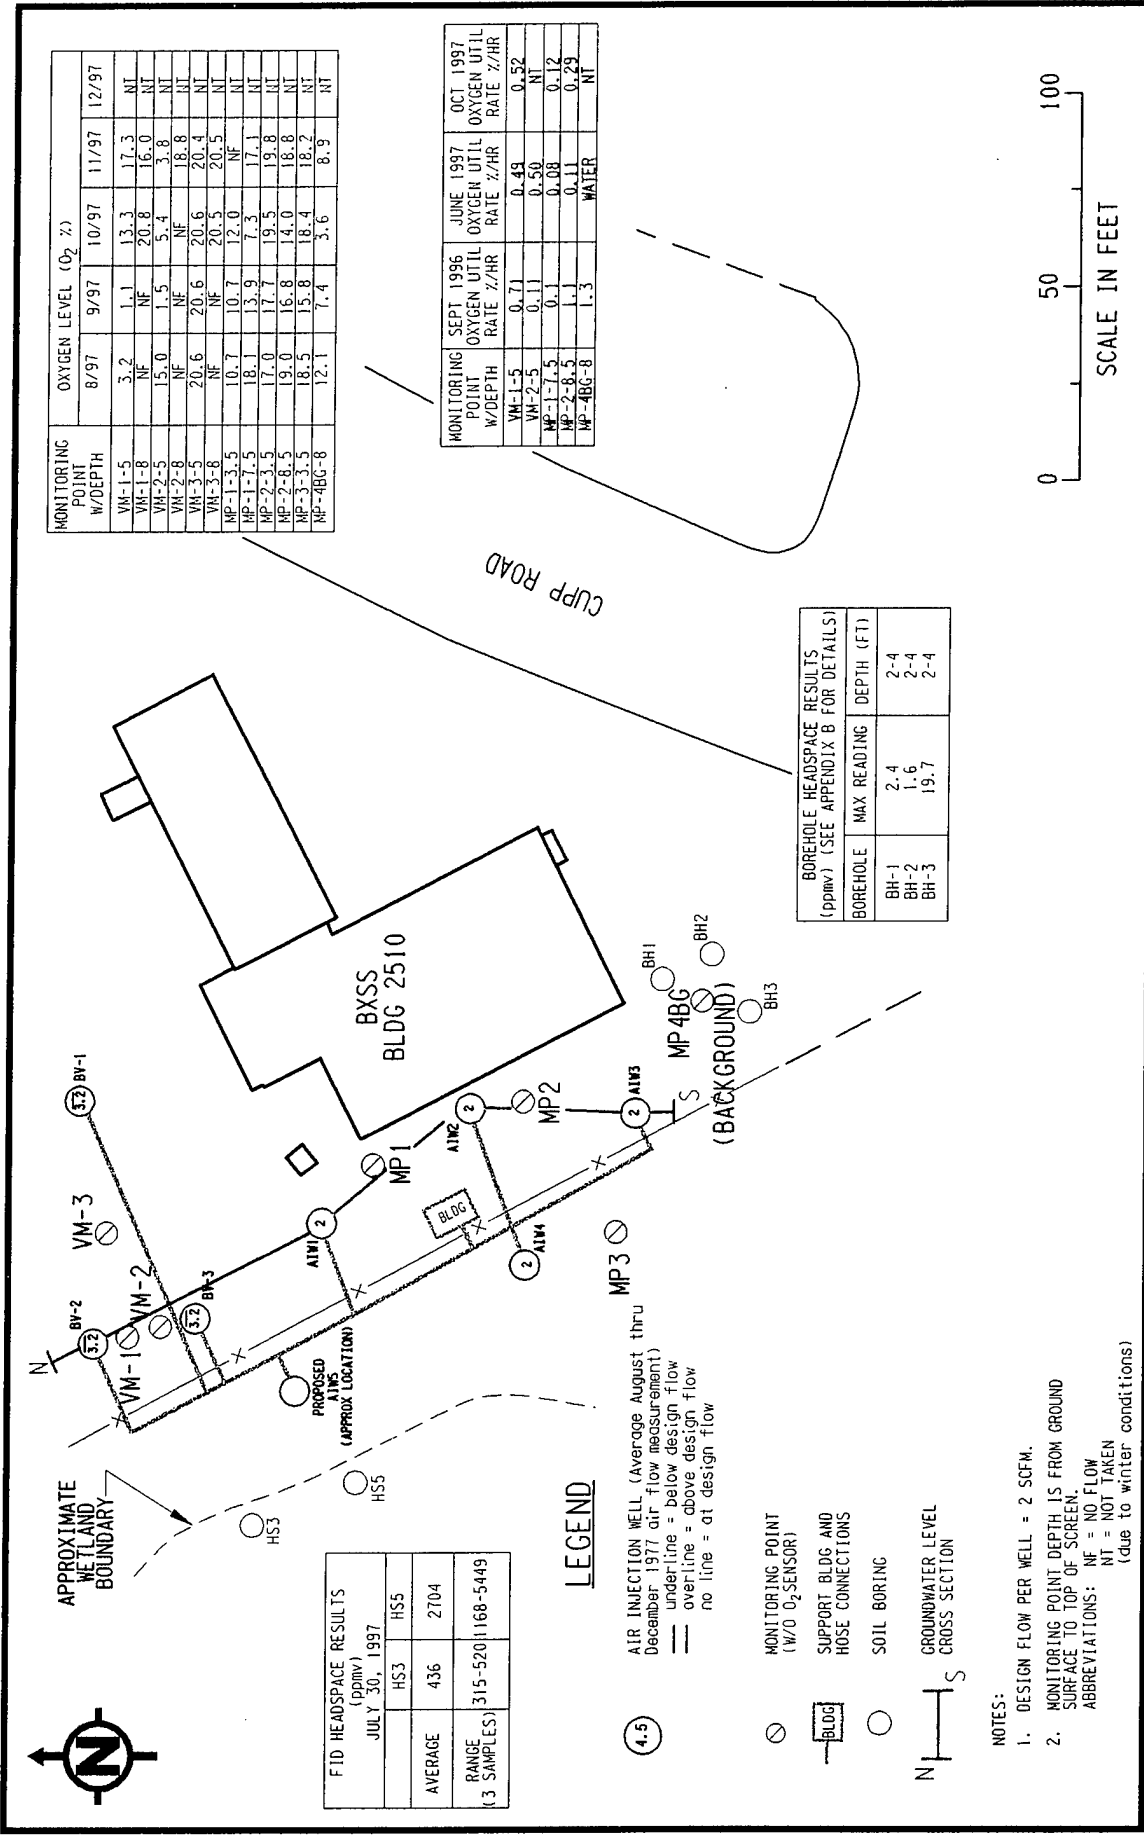
Figure 5-1
BXSS Biovent System Layout
and Average Wellhead Flow

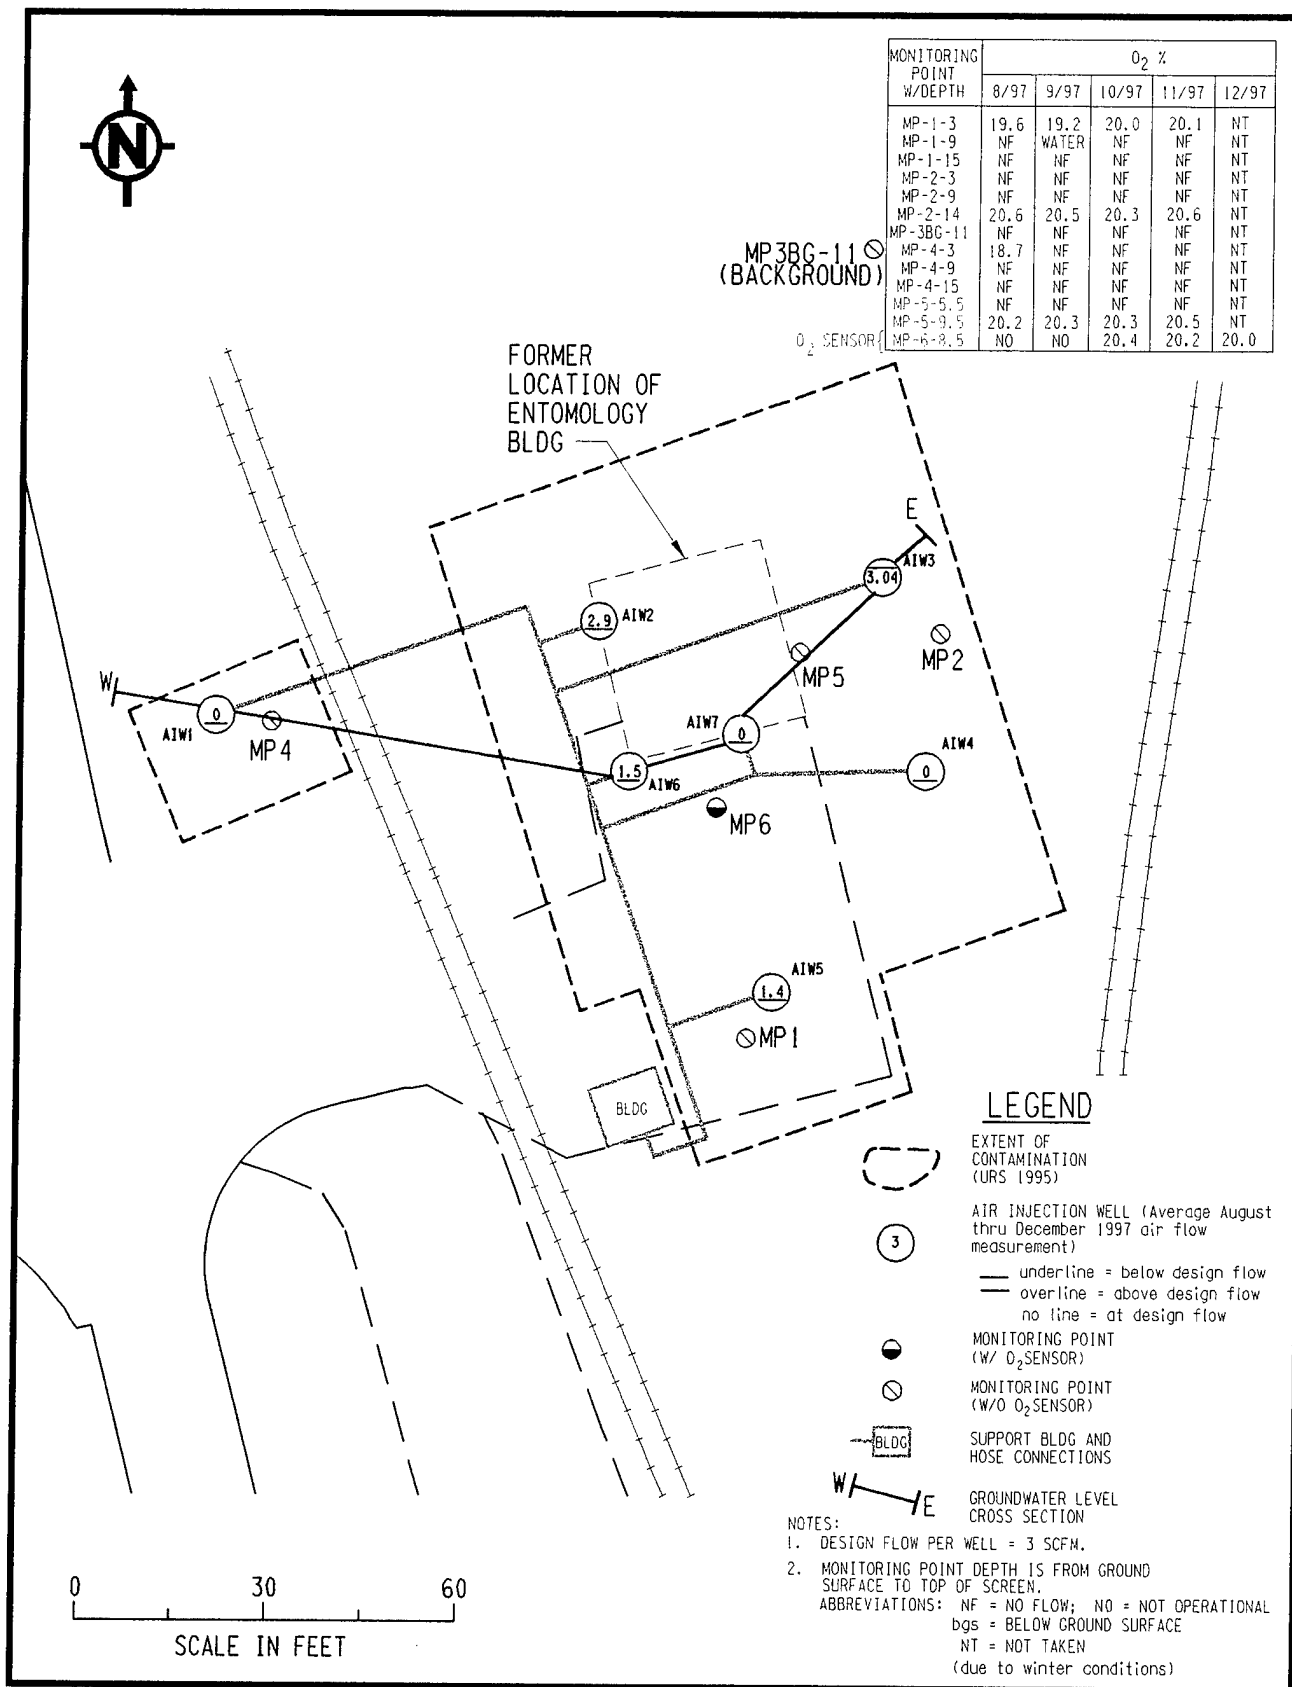
Figure 6-1
ES Biovent System Layout
and Average Wellhead Flow
